El Cantil

Administrative Report
3rd Quarter 2015
Aug and Septiembre

BUILDING MAINTENANCE AND GARDENING
(Highlights)

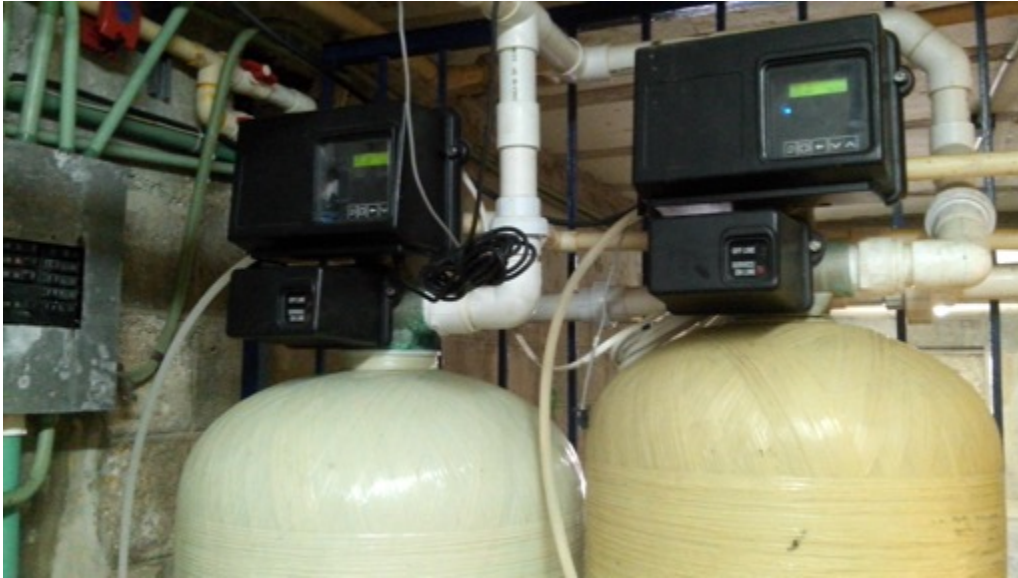
South tower water softener and filters:

Two head units were replaced and programmed. One of the heads was repaired and is stored for future use:

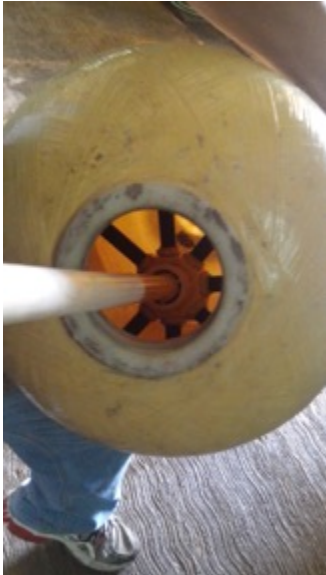
Elements inside the filters were replaced:

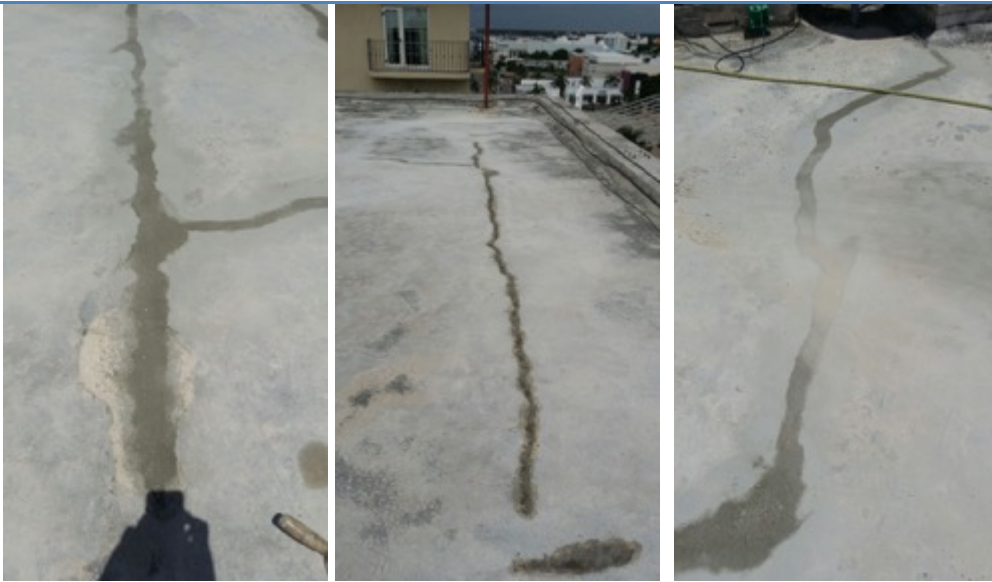
Roof Repair:

Cracks properly repaired before application of roof sealant:

Repaired cracks in roof and applied a special white roof sealant to the entire surface of the roof. The south tower roof is finished. They did a fantastic job.

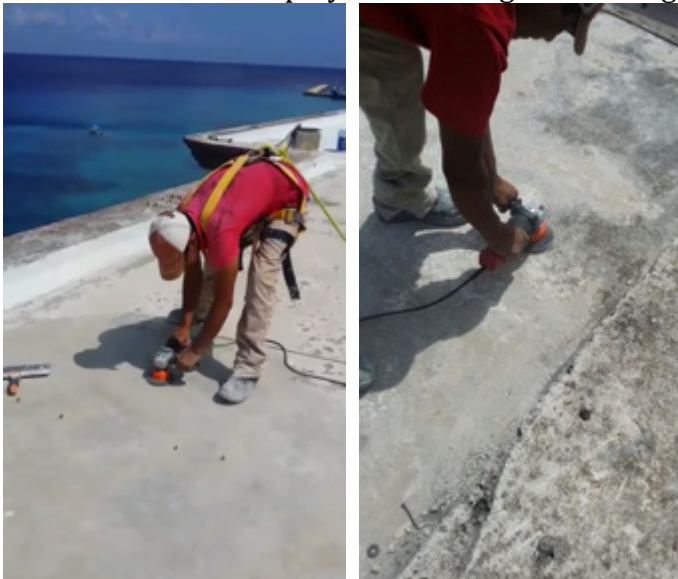
Roof surface was thoroughly prepared before application of Roof Sealant. Note also the safety measures taken. Employees near edges are using harnesses:

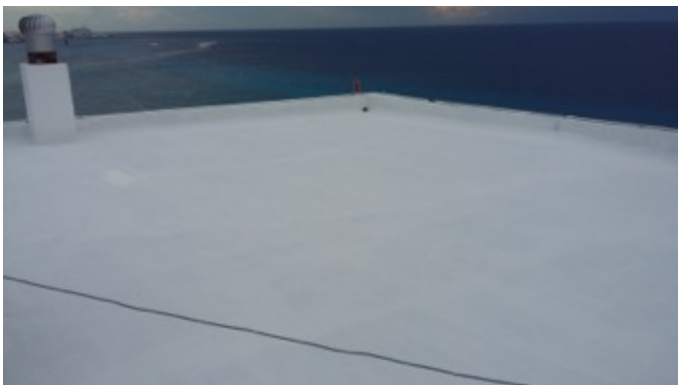
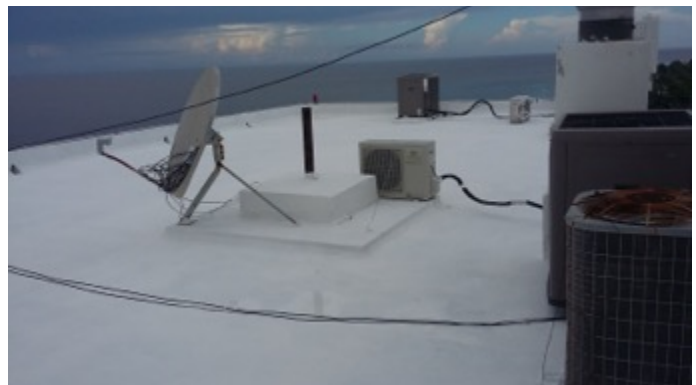
For extra protection, mesh was added to areas where cracks were repaired. The roof sealant is the latest and greatest product and will protect the roof for at least 5 years. After 5 years it will still be strong, however as part of normal preventative maintenance and to reinforce the strength of the existing sealant we could add one more coat of sealant.

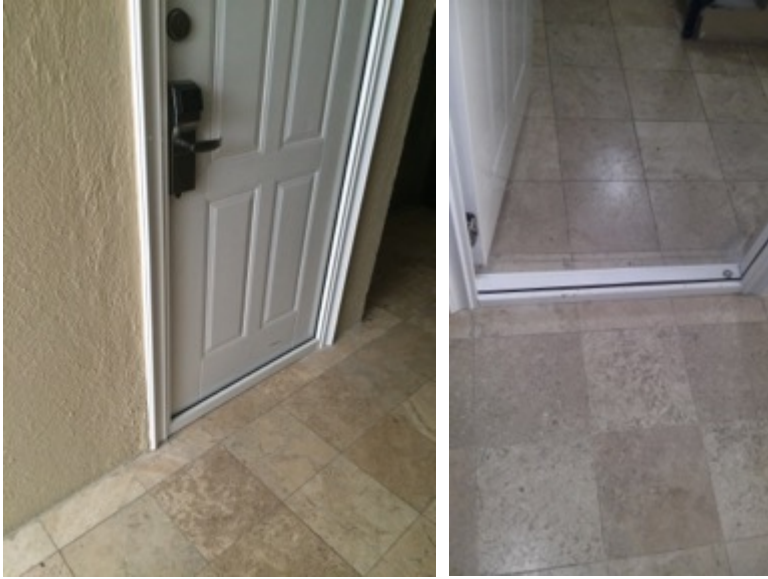
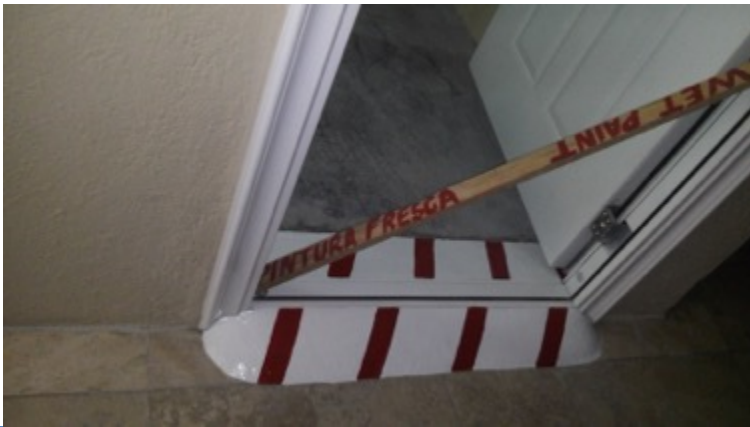
New doors were a trip hazard:

- Repaired - Before/After -

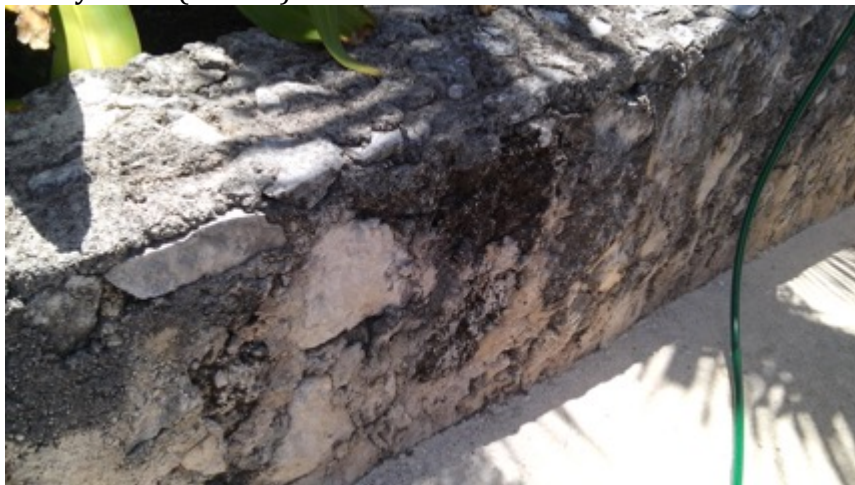
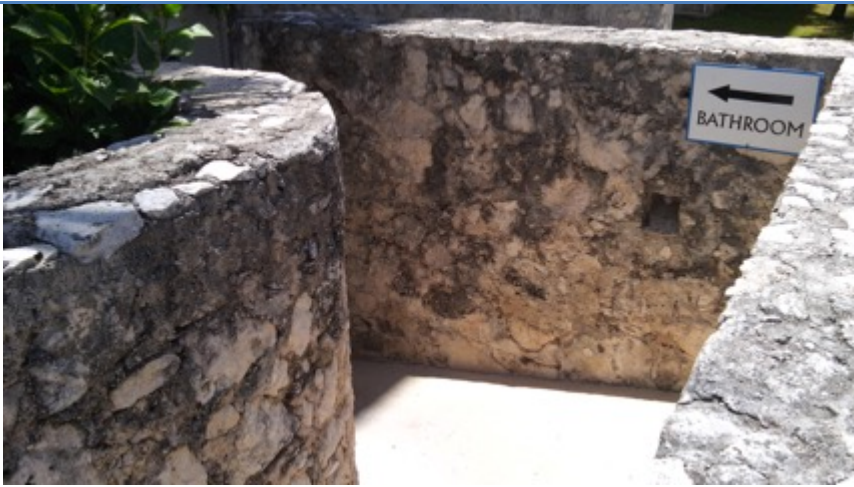
Moldy walls (Before):

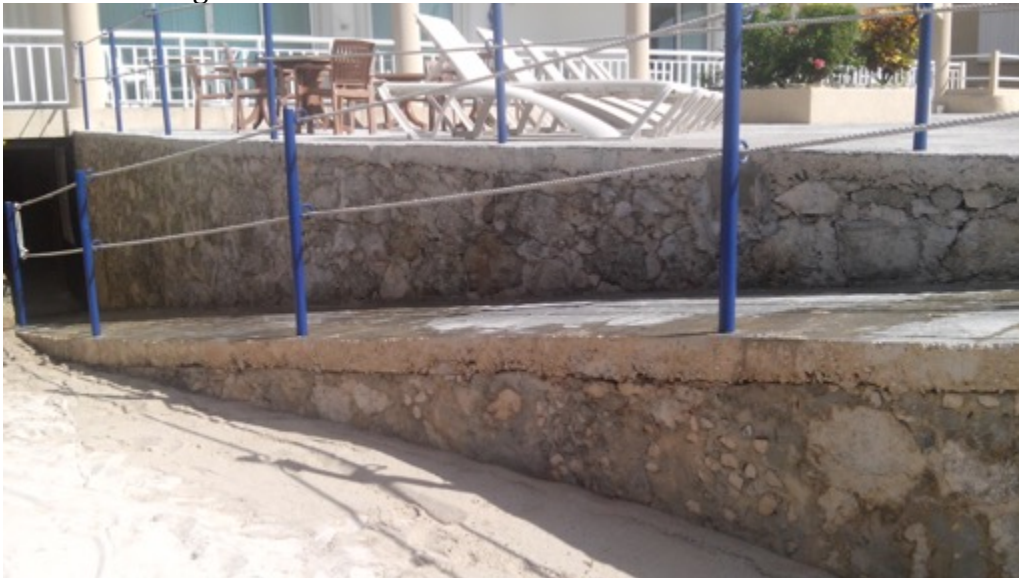
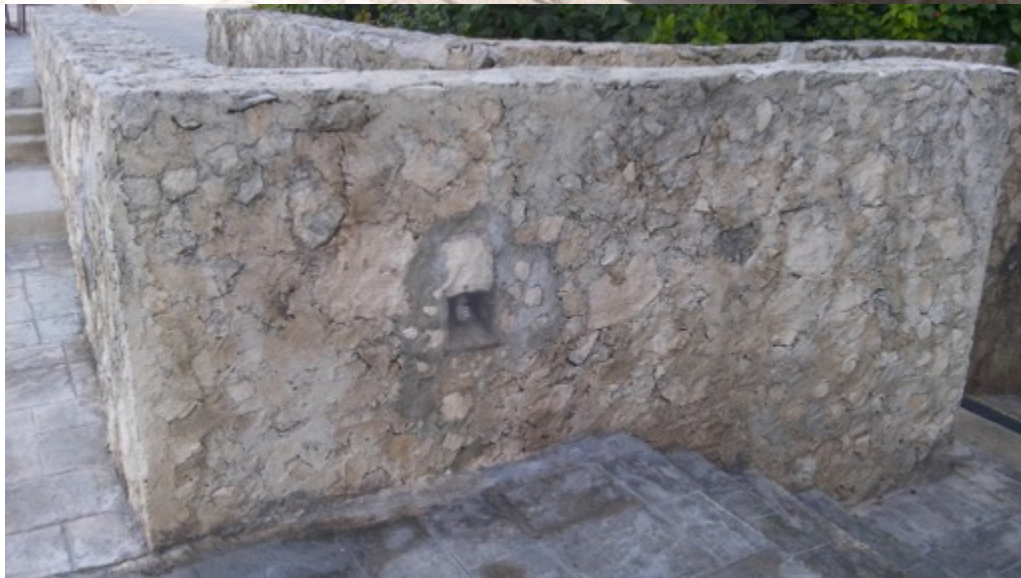
-After Cleaning-

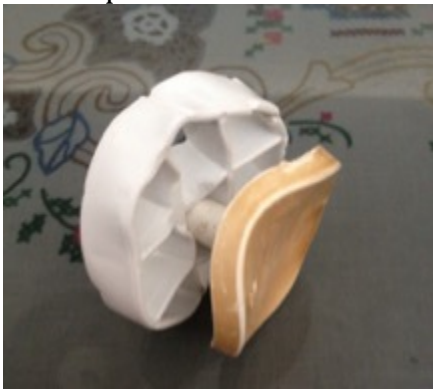
Pool system has a salt water chlorinator that was damaged due to overheating and possibly too much water pressure.

Melted piece from inside chlorinator:

-Chlorinator Replaced-

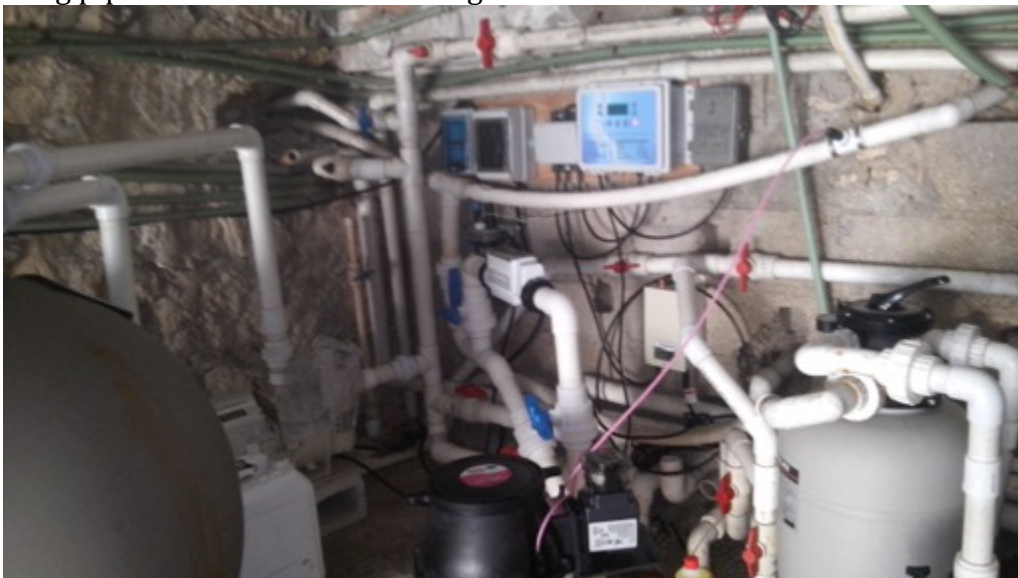
Long pipe bowed from overheating:

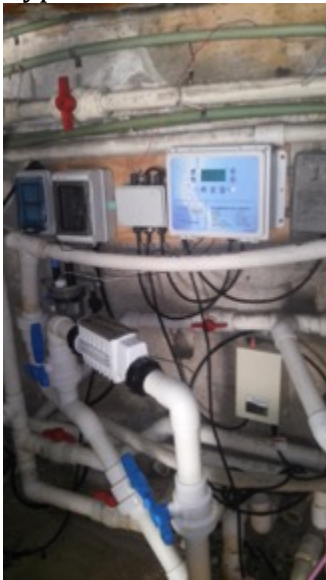
Bypass installed for new chlorinator to reduce/control water flow and pressure:

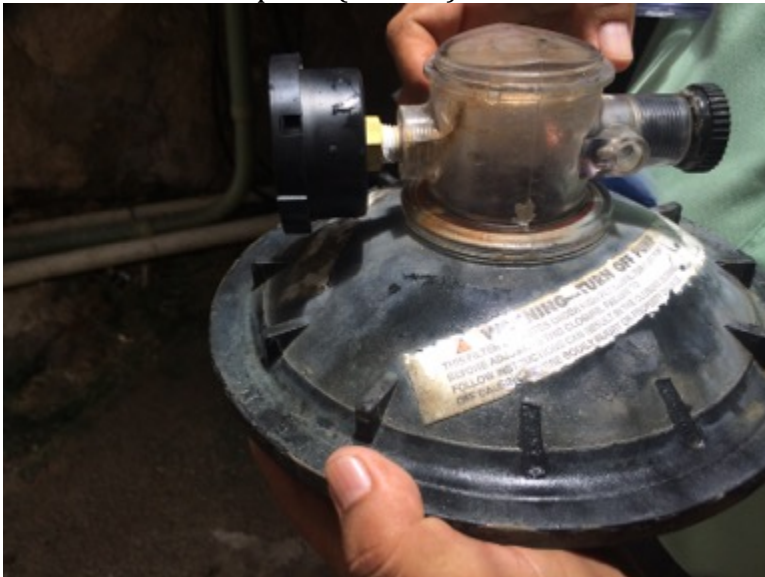
- Pool Filter Lid Replace (Leaked) -

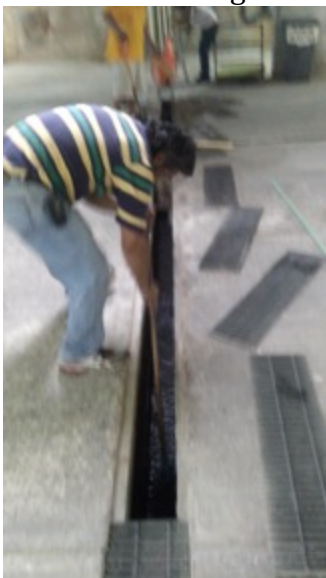
Cleaned out sludge from parking lot drain:

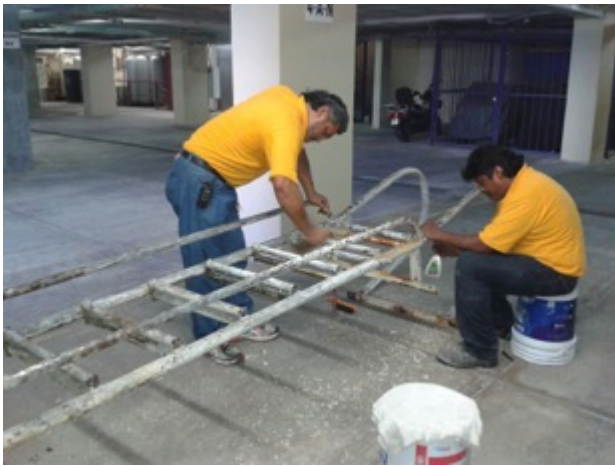
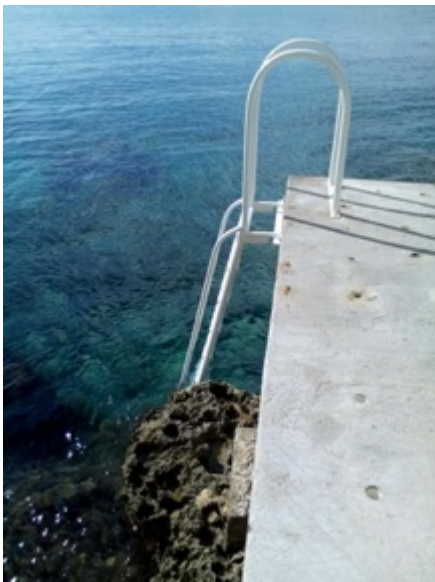
Pier Ladder:

-Removed, sanded, sealed and painted-

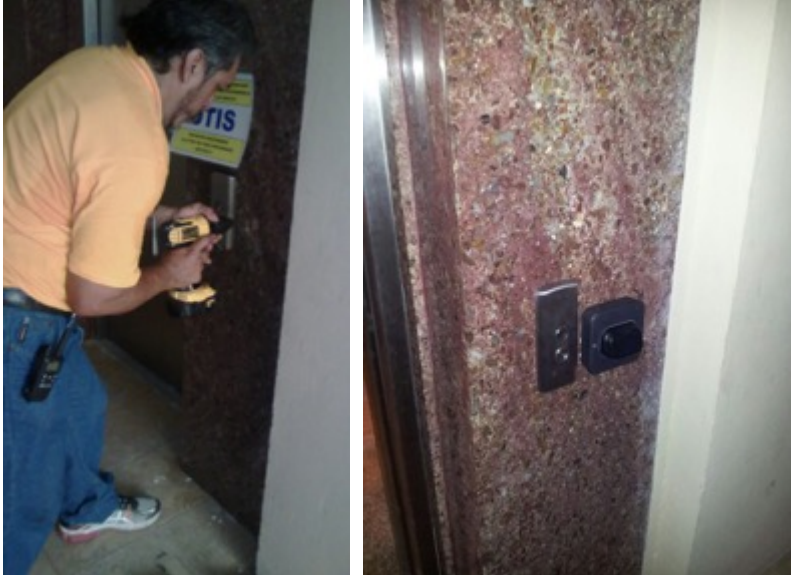
For safety reasons, the card reader for elevator 4 has been moved outside.

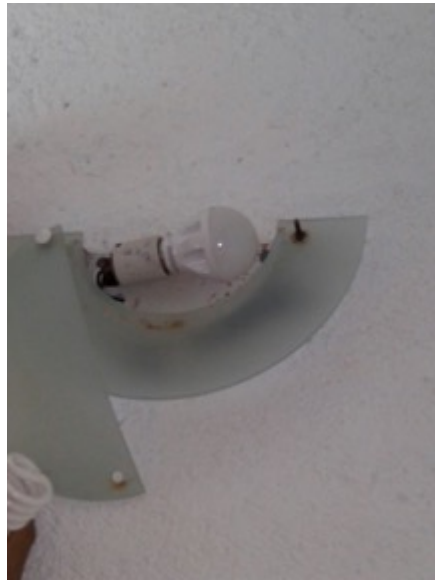
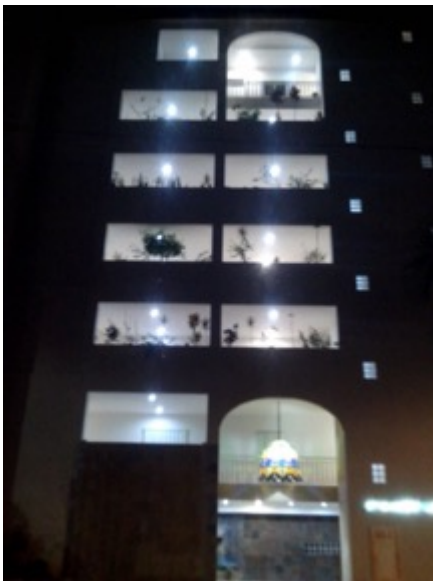
- LED Light bulbs -

High quality LED (5 watt) light bulbs were purchased from a provider in DF to replace all burnt out light bulbs, incandescent bulbs (60/70 watts), and florescent bulbs (14/18watts). This will represent a large savings in electricity every month plus LED light bulbs last much longer.

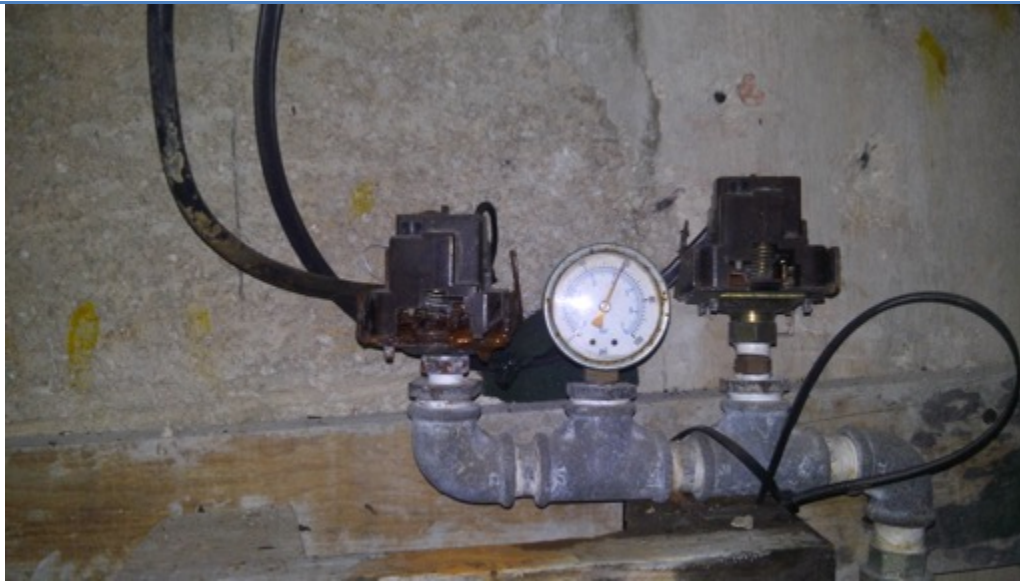
- One pressure gauge failed and the other was very old so we preplaced both -
Before/After

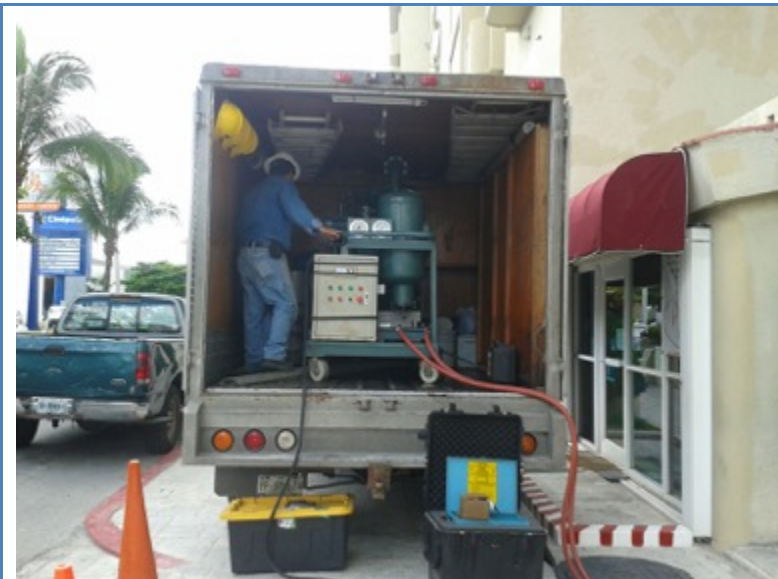
Transformers Serviced:

One of the transformers had an oil leak which needed urgent attention. This transformer as well as the other 5 were inspected and serviced. Reports will be prepared for us that will tell us if further repairs are needed.
